OLD WATKINS NATIONAL BANK

Lawrence, Kansas

WINDOWS NUMBER 5

Interior Metal Storm Windows

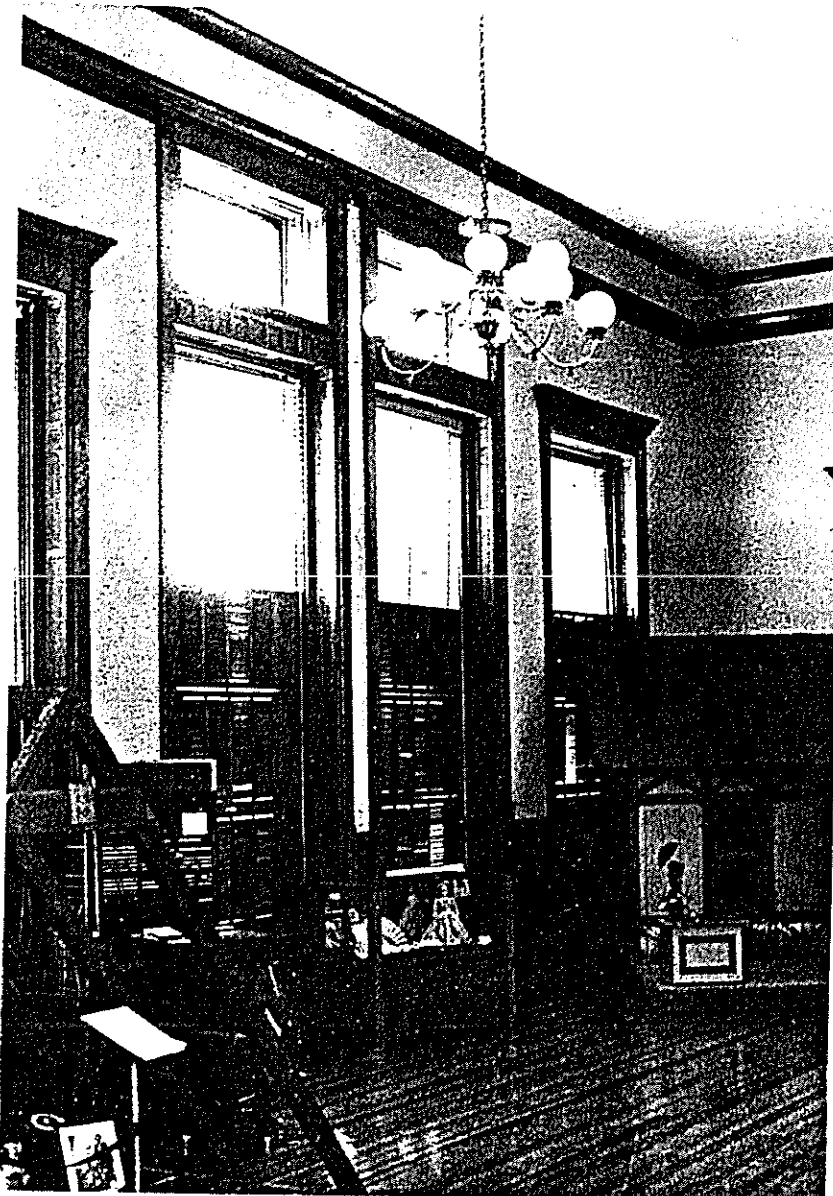
Figure 1. The monumental windows are elegantly detailed on the interior and contribute to the grandeur of the spacious banking rooms. The original interior shutters are still being used for comfort and light control. Photo: Charles E. Fisher

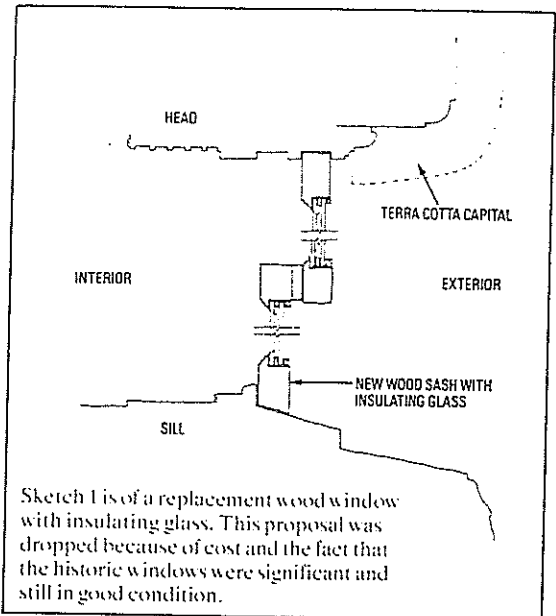
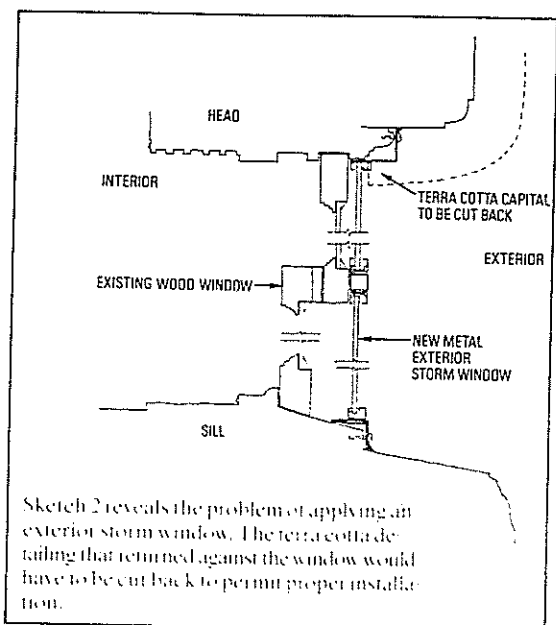
Figure 2. As part of the planning, the architect prepared sketches of 4 possible window treatments to improve the energy performance of the windows.

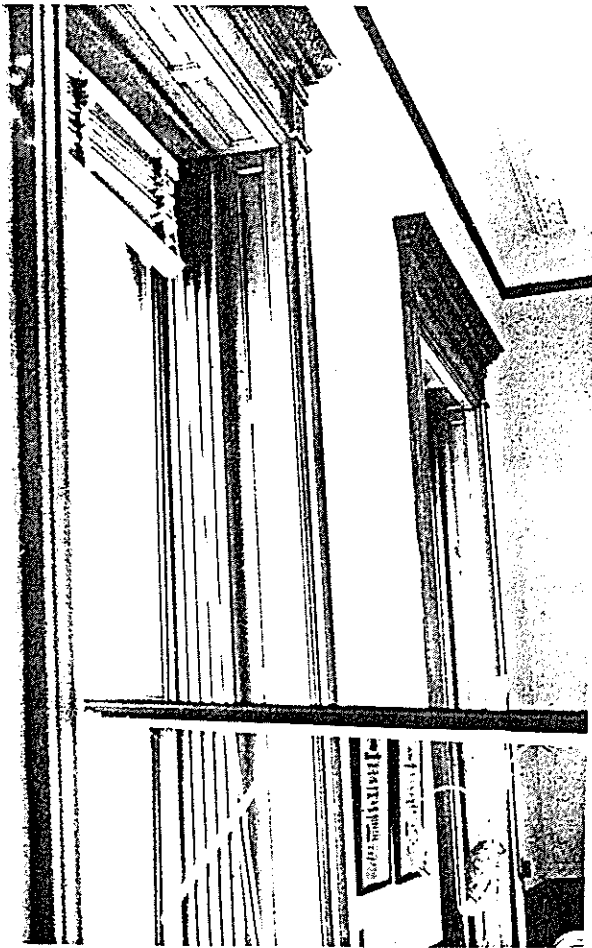
Figure 5. The interior storm window was designed to fit within the existing wooden jamb. The large size of the windows necessitated the use of operable storm panels, intersecting at the historic meeting rail. Here the lower storm panel is in an opened position for cleaning. Photo: Charles E. Fisher

The thin aluminum storm window frame ($\frac{7}{8}$ " wide, $1\frac{1}{2}$ " deep) was attached to a small new subframe by two pins that allowed the windows to pivot open for cleaning and venting in case entrapped condensation was ever a problem (see figure 5).
