# COLORADO STATE REGISTER OF HISTORIC PROPERTIES NOMINATION FORM

Property Name Denver & Rio Grande Railroad Antonito Depot
SECTION II
Local Historic Designation
Has the property received local historic designation?
⊠ no
yes individually designated designated as part of a historic district
Date designated
Designated by (Name of municipality or county)
Use of Property
Historic Railroad Depot
Current Not in use
Original Owner Denver & Rio Grande Railroad
Source of Information Denver & Rio Grande Western Railroad, "Official Roster No. 11 of the Denver
Rio Grande Western Railroad System and the Rio Grande Southern Railroad Company, 1923."
Year of Construction 1880
Source of Information <u>Denver &amp; Rio Grande Western Railroad, "Official Roster No. 11 of the Denver</u>
Rio Grande Western Railroad System and the Rio Grande Southern Railroad Company, 1923."
Architect, Builder, Engineer, Artist or Designer Denver & Rio Grande Railroad
Source of Information Denver & Rio Grande Western Railroad, "Official Roster No. 11 of the Denver

#### **DESCRIPTION and ALTERATIONS**

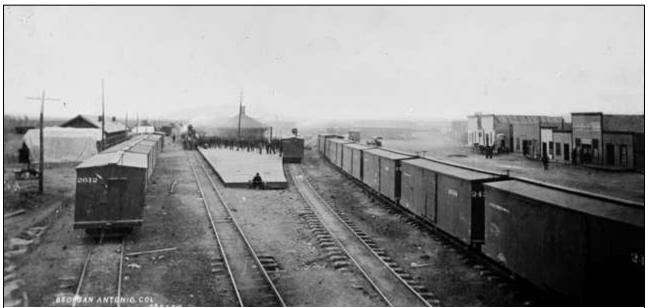
Figure 1. This circa 1880 view looking south in Antonito shows the depot with an expansive wood platform between the tracks. Source: Western History / Genealogy Department, Denver Public Library.

Over time, the depot employed a variety of semaphore signal devices to control train movements. None of these systems survives. A raised wood platform originally surrounded the depot. (See *Fig. 1*.) This was later replaced with a concrete platform. (See *Figs. 2* and 7.)

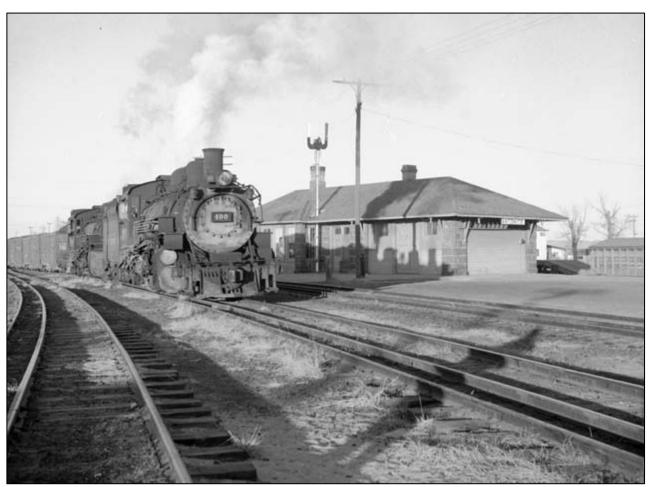
Figure 2. A west-bound freight train passes the west side of the Antonito Depot on January 29, 1958. The three sets of tracks contain three rails each to accommodate both narrow gauge and standard gauge cars. Photographer: Robert W. Richardson. Source: Western History / Genealogy Department, Denver Public Library.

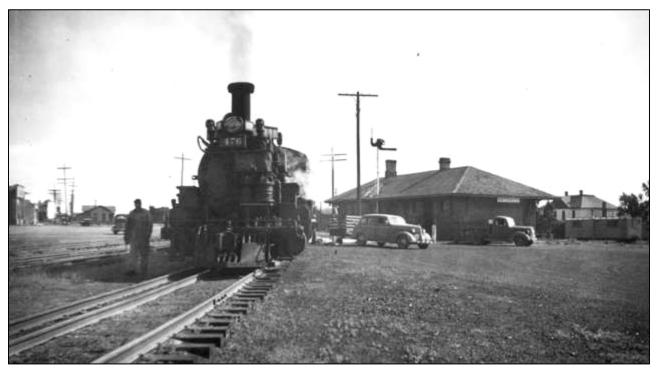
Figure 3. This view of a west-bound train in about 1940 shows the depot's west and south elevations. Source: Western History / Genealogy Department, Denver Public Library.

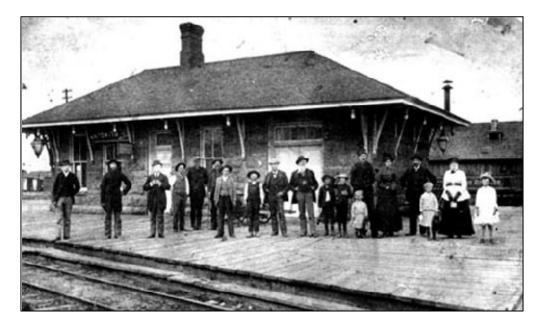
Figure 4. The photographic view looking east shows the depot in its original size shortly after construction in 1880. Source: Colorado Historical Society.

Photographic evidence indicates that all the major changes to the depot occurred prior to 1940. As originally constructed in 1880, the depot was shorter with all exterior walls composed of stone. (See *Fig. 4*) At an unknown time but most likely early in its operation, the Rio Grande expanded the depot to the south. This created additional office and baggage/freight space. The middle portion of the southern stone wall was removed to provide access to the new baggage area. The removed stone was recycled to form the corner piers in the addition. Rather than obtain additional stone to enclose the new space, the builders framed in the three exterior walls, as well as the open space in the old southern stone wall. Sliding freight doors flanked by high windows were placed in the middle of the west and east baggage room walls. The original baggage door openings were converted to pedestrian entries by recycling some original stone to partially infill the base of each opening and by installing a large side light above to flank the new wood panel door. The former transoms were removed and infilled with wood framing covered in stucco. A new chimney unlike the original in design rose through the extended hipped roof. Only the northern-most chimney now remains. Original wood brackets appear to have been reused around the extended roof.

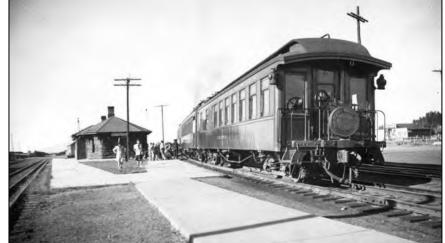
Figure 7. The parlor-buffet car "Durango" brings up the rear of a west-bound passenger train stopped at the Antonito Depot in 1940. Photgrapher: Otto Perry. Source: Western History / Genealogy Department, Denver Public Library.

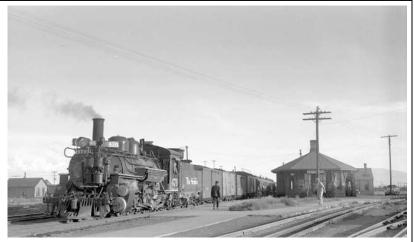
Figure 8. The last revenue train to run on the Santa Fe Branch, a mix train of freight and passenger cars, pauses at the Antonito Depot on September 1, 1941. Photographer: Otto Perry. Source: Western History / Genealogy Department, Denver Public Library.

The history of the east side bay is unclear. The extension currently contains toilet facilities. As constructed in 1880, the depot may not have included a toilet. Staff and passengers probably used a nearby privy. The wood frame and stucco construction suggests that the extension was not part of the original design. A 1941 photograph (*Fig. 8*) shows a roof vent that identifies the space as a water closet.

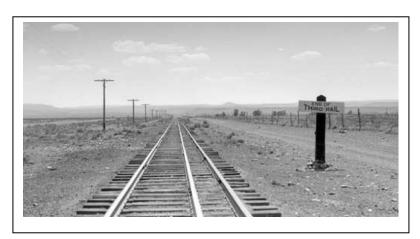
Figure 9. The end of the three-rail track comes just west of Antonito, marking the end of standard gauge operation on the San Juan Extension. Photographer: Otto Perry, June 21, 1943. Source: Western History / Genealogy Department, Denver Public Library.

The D&RG usually began the conversion of a particular route by replacing narrow gauge ties with longer standard gauge type and then adding an outside third rail to the existing narrow gauge track to allow the operation of both gauges over the same railbed. Once a route was fully converted to standard gauge, the inner rail allowing narrow gauge operation was removed. In the San Luis
