United States Department of the Interior National Park Service National Register of Historic Places Registration Form

Historic name Tobasco Mine and Mill

Tobasco Mine and Mill
Hinsdale County/ San Juan County, Colorado
Hinsdale County Metal Mining MPS

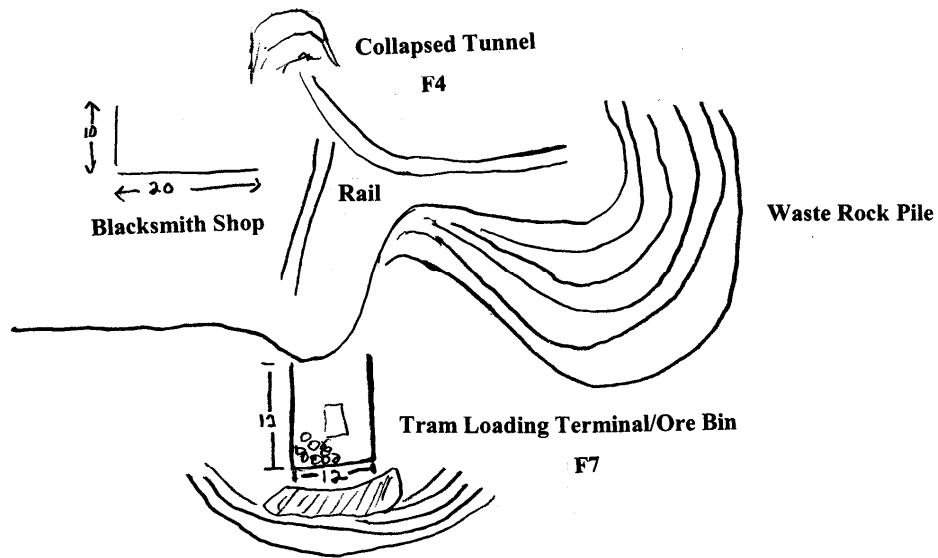
5SA399/5HN49
Tobasco Gold Mine and
Mill
Features #4 and #7

Feature 4 is a mine tunnel and waste rock pile with two associated collapsed buildings. The now collapsed tunnel opening was excavated into bedrock. The waste rock pile is approximately 65 feet wide and 15-20 feet high. One collapsed structure measures 5 feet by 5 feet and appears to have been constructed of heavy timbers covered with heavy gauge metal. Given the use of heavy timbers, it may have been a powder house. The second collapsed building consists of a board and timber scatter adjacent to the mine adit. The building measured approximately 10 feet by 20 feet, and appears to be the remains of a small mine shop, and it may be one of the two blacksmith shops referred to in the October 10, 1902, Colorado Bureau of Mines, *Mine Report*. Several poles with cross-tees were noted on the slope between this feature and Feature 1. The poles appear to be electric line poles. Features 1, 3, and 4 are aligned vertically on the slope of Cinnamon Mountain on the same vein or fault.

Feature 7 is a tram system consisting of two tram terminals/ore bins, four standing tram towers, and the collapsed ruins of thirteen tram towers. The tram system connects the mine tunnel at Feature 4 with the mill (F11), a distance of approximately 7,800 feet. The tram loading terminal/ore bin at the mine tunnel (F4) contains a loading floor and a tram loading structure. It was constructed of wood posts (10" by 10") and heavy lumber (2" x 12") arranged into a sloped floor at an angle of 45 degrees. A portion this loading floor in the ore bin was clad with sheet metal to protect it from the wearing action of the ore tumbling across it. The loading floor retains a small amount of ore. The structure enclosing the tram terminal/ore bin has totally collapsed or been scavenged, so it is not clear how it was constructed. The footprint of this building appears to be 12 feet by 18 feet. Wire cables and some hardware for the tram are present in the collapsed ruins. Of the seventeen tram towers, only four remain standing. They were pyramid towers constructed of four log posts arranged into a double "A" frame approximately eighteen feet high, with six foot long timber post arms extending across the top to support two wire cables. The tram was a Leschen Tramway. According to the *Lake City Times*, "The tramway is being erected by the Leschen people of St. Louis, which in itself, is a guarantee that it will be put up in the best possible manner" (July 31, 1902). Associated artifacts such as wire cables and a bucket frame are present around one of the collapsed towers.

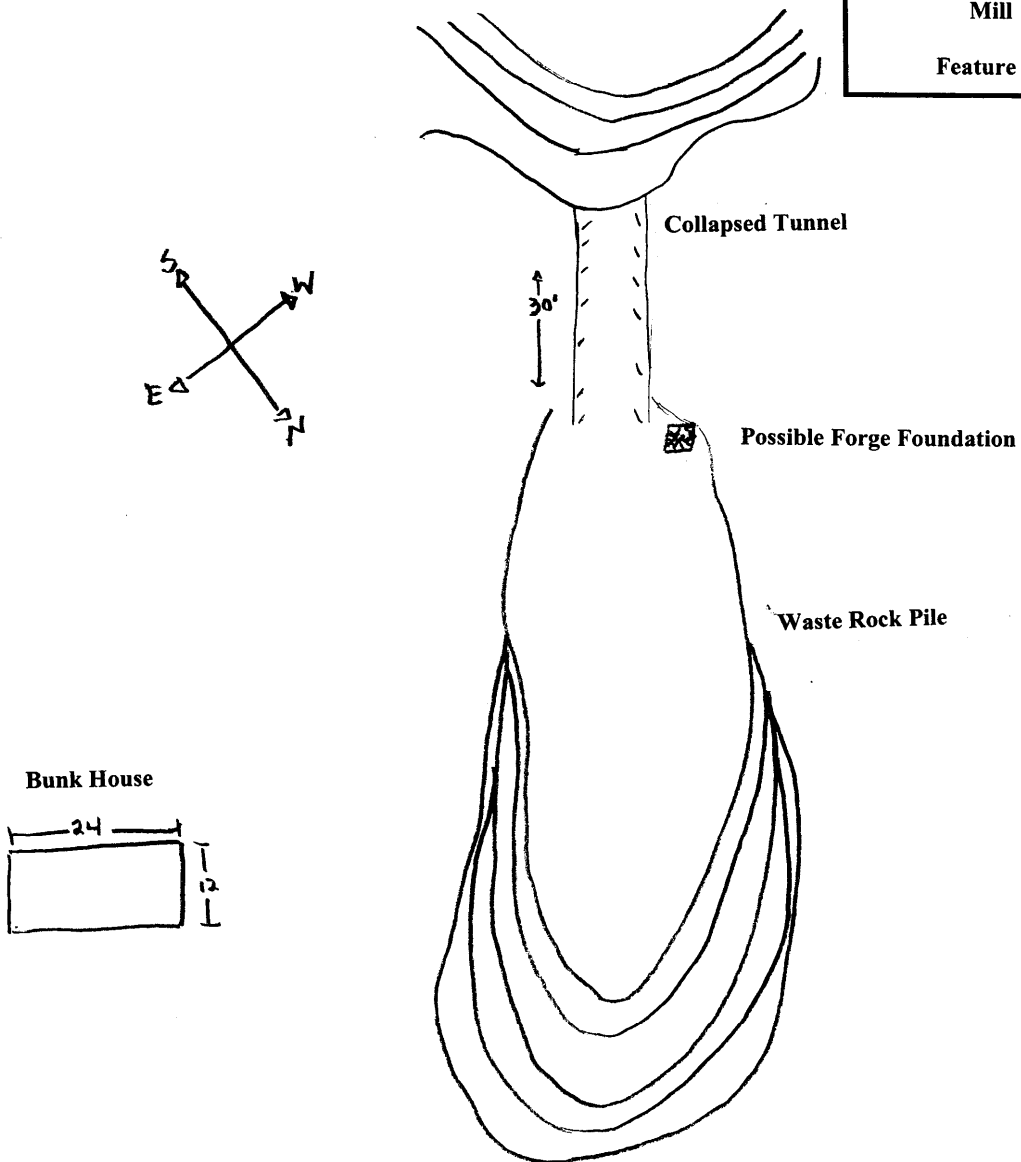
5SA399/5HN49
Tobasco Gold Mine and
Mill
Feature #5

Feature 5 is another mine tunnel complex located southeast of and at the same level as Feature 4. A collapsed linear tunnel is located in the rock scree. This collapsed tunnel is currently about three feet deep with badly decomposed timbers and posts are exposed along its length. This is most likely the timbered tunnel described in the 1898 mineral survey for the Gold Crown and Gold Bar lodes. The mine waste rock pile is approximately 20 feet wide, 80 feet long, and 20 feet high. At the lower end and northwest of the tunnel is a small platform constructed of local rock and timbers measuring four feet by four feet. This rock platform probably formed the foundation for a forge in the blacksmith shop described in the same mineral survey. Southeast of and adjacent to the waste rock pile is the foundation of a building. This foundation has a rectangular footprint, 24 feet long (northwest-southeast) by 12 feet wide, and is primarily defined by loosely piled stone. The stone is especially notable on the downhill side where it is 2 feet high. Artifacts noted in and around the foundation include purple and brown glass, hole-in-top cans, cast iron stove fragments, charcoal, and wire nails. Based on the artifacts and the foundation dimensions, this building was most likely the frame bunkhouse mentioned in the same 1898 mineral survey (MS12940).

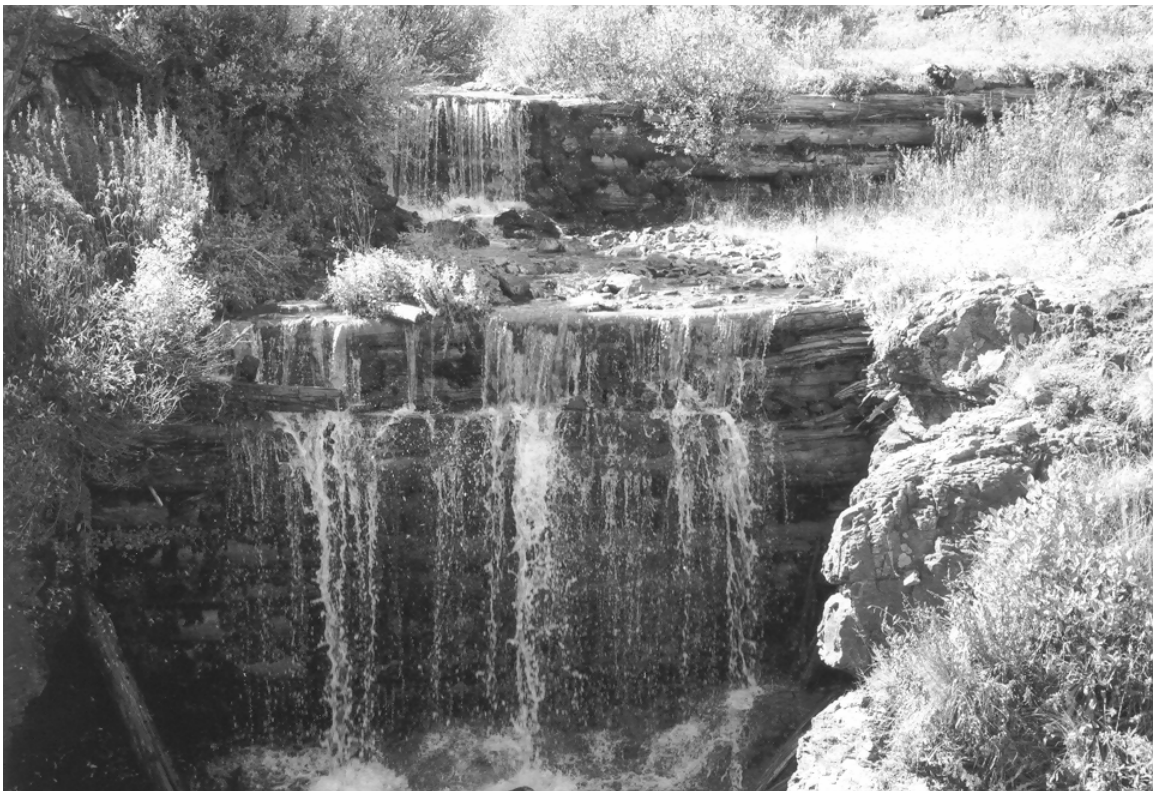
Feature 13 consists of two log dams directly downslope and across the road from the mill. The dams hold back an unnamed tributary of the Lake Fork of the Gunnison River. The dams are constructed of long horizontal stacked logs with tie beams placed perpendicular to the stacked logs. The first dam is 30 feet wide across the stream and appears to be about six feet high. The second dam is approximately 18 feet downstream from the first dam and has two logs that form a step like feature above 13 logs that measure about 20 feet in width and 20 feet high.

Photo No.	Photographic Information
6	Tobasco Dam (F13), looking northwest.
7	Tobasco Mill (F11), detail of vanner.
8	Tobasco Mill (F11), overview of Mill ruins, looking north. Tram receiving terminal/ore bin in center background.
9	Tobasco Tram Receiving Terminal/Ore Bin (F7), looking west.
10	Tobasco Tram Receiving Terminal/Ore Bin (F7), Tram Receiving Terminal/Ore Bin, foreground; Cinnamon Mountain background center, looking west.
11	Tobasco Tram (F7), looking east, this is the lowest standing tram.
12	Tobasco Tram (F7), looking east, this is the second to the lowest standing tram.
13	Tobasco Tram (F7), looking east, this is the second to the highest standing tram.
14	Tobasco Tram (F7), looking east, this is the highest standing tram.
15	Collapsed Tobasco Tram (F7), looking southwest; F9 an adit is in the upper left corner.
16	Overview of Tobasco Trams (F7), looking east; all four standing trams are in photo center

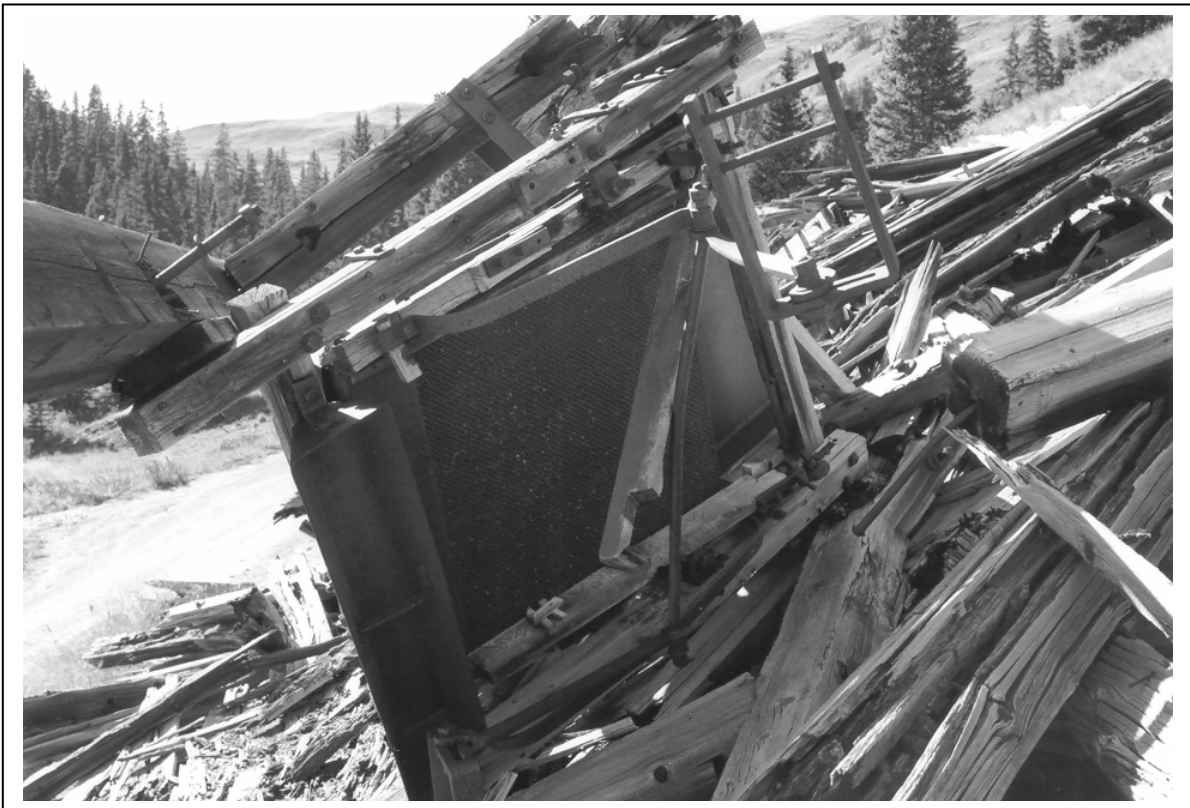
7

The Tobasco Mill (Feature 11) is located on the south slope of Edith Mountain at 11,600' elevation along the Cinnamon Pass Road. The Cinnamon Pass Road (Hinsdale County Road 30 and San Juan County Road 2) is the route of the historic Otto Mears Toll Road built by Enos Hotchkiss in 1875. The wood frame of the Mill building has completely collapsed. The footprint of this building is approximately 100 feet by 40 feet. It was constructed of large timbers (6" x 6" to 12" x 12") and dimensional lumber. Several pieces of milling equipment are visible in the ruins including a fine ore crusher (stamped "Colorado Iron Works, Denver, CO") and three vanners. The October 10, 1902, Colorado Bureau of Mines, *Mine Report*, stated that the Tobasco Mine and Milling Company had constructed a 100-ton Mill. The October 9, 1902, "Lake City Times" reported that the Tobasco Mill was a 150-ton cyanide mill.

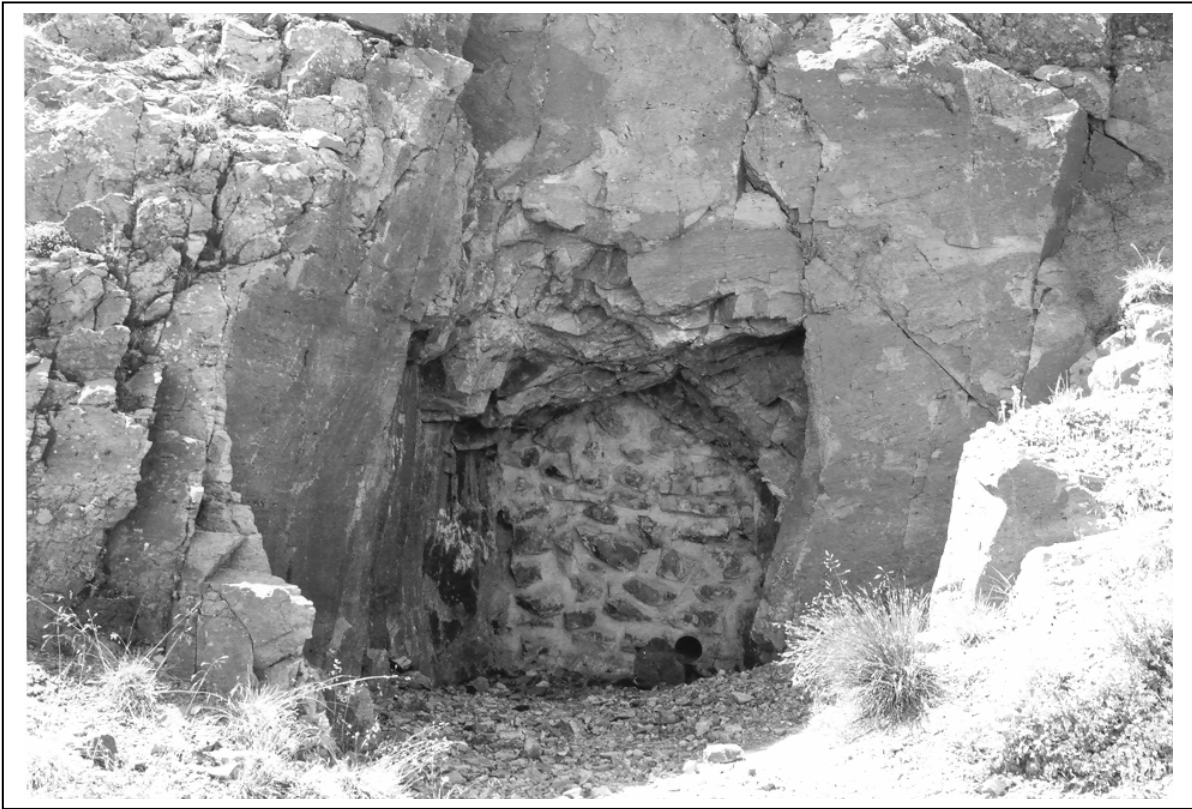
17	Tobasco Mine Adit (F9), looking southwest.
18	Tobasco Boarding House (F6), looking north.
19	Tobasco Tram Loading Terminal/Ore Bin (F7), looking east.

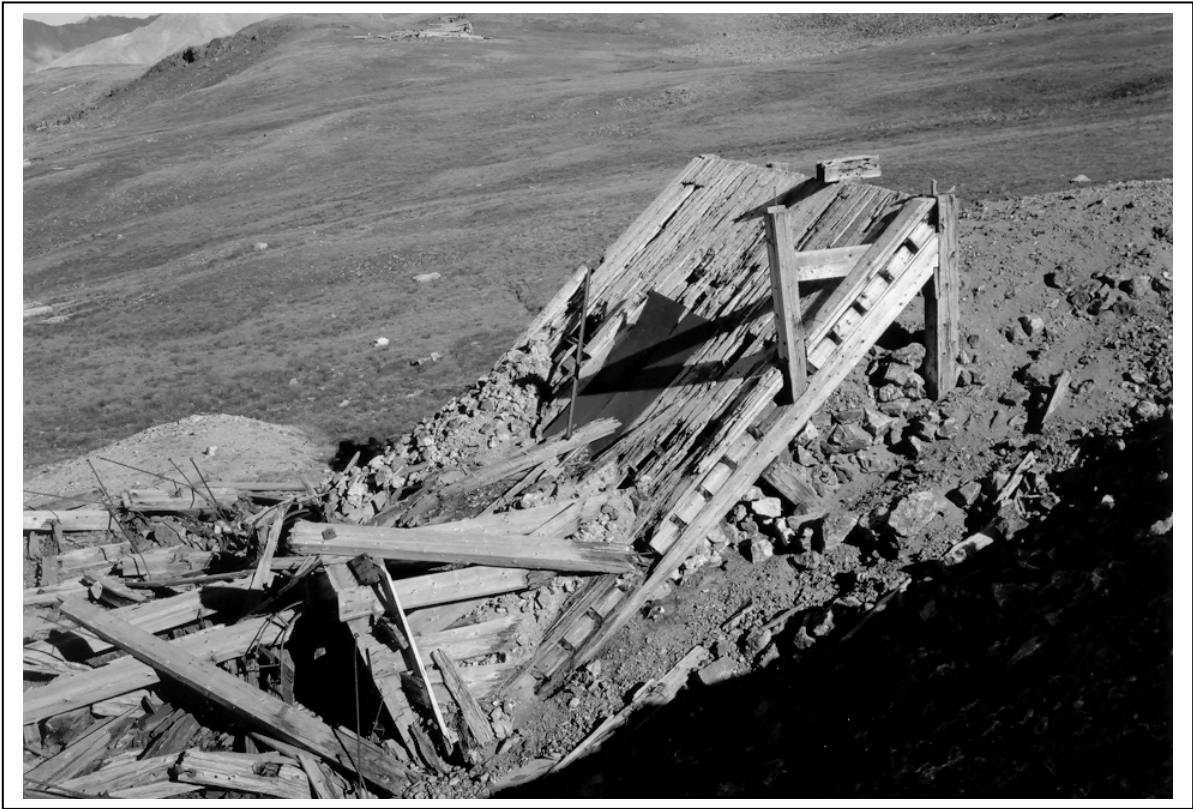
The lower tram receiving terminal/ore bin (F7) is located upslope from the ruins of the mill. The tram receiving terminal is constructed of timber frame posts (12" x 12") that stand over two stories high. The dimensions of this building are 38 feet by 24 feet. The frame is still standing, but there is no siding or roofing. The sloped floor (45°) of the ore bin is constructed of large plank lumber. Ore from the tram buckets was dumped onto this sloped floor and then moved downslope into the mill.
