United States Department of the Interior
National Park Service
National Register of Historic Places
Registration Form

historic name Greeley Downtown

other names/site number 5WL.5652

**National Register of Historic Places  
Continuation Sheet****United States Department of the Interior  
National Park Service**Greeley Downtown  
Weld County/ ColoradoSection number 7 Page 1**DESCRIPTION****General Description**

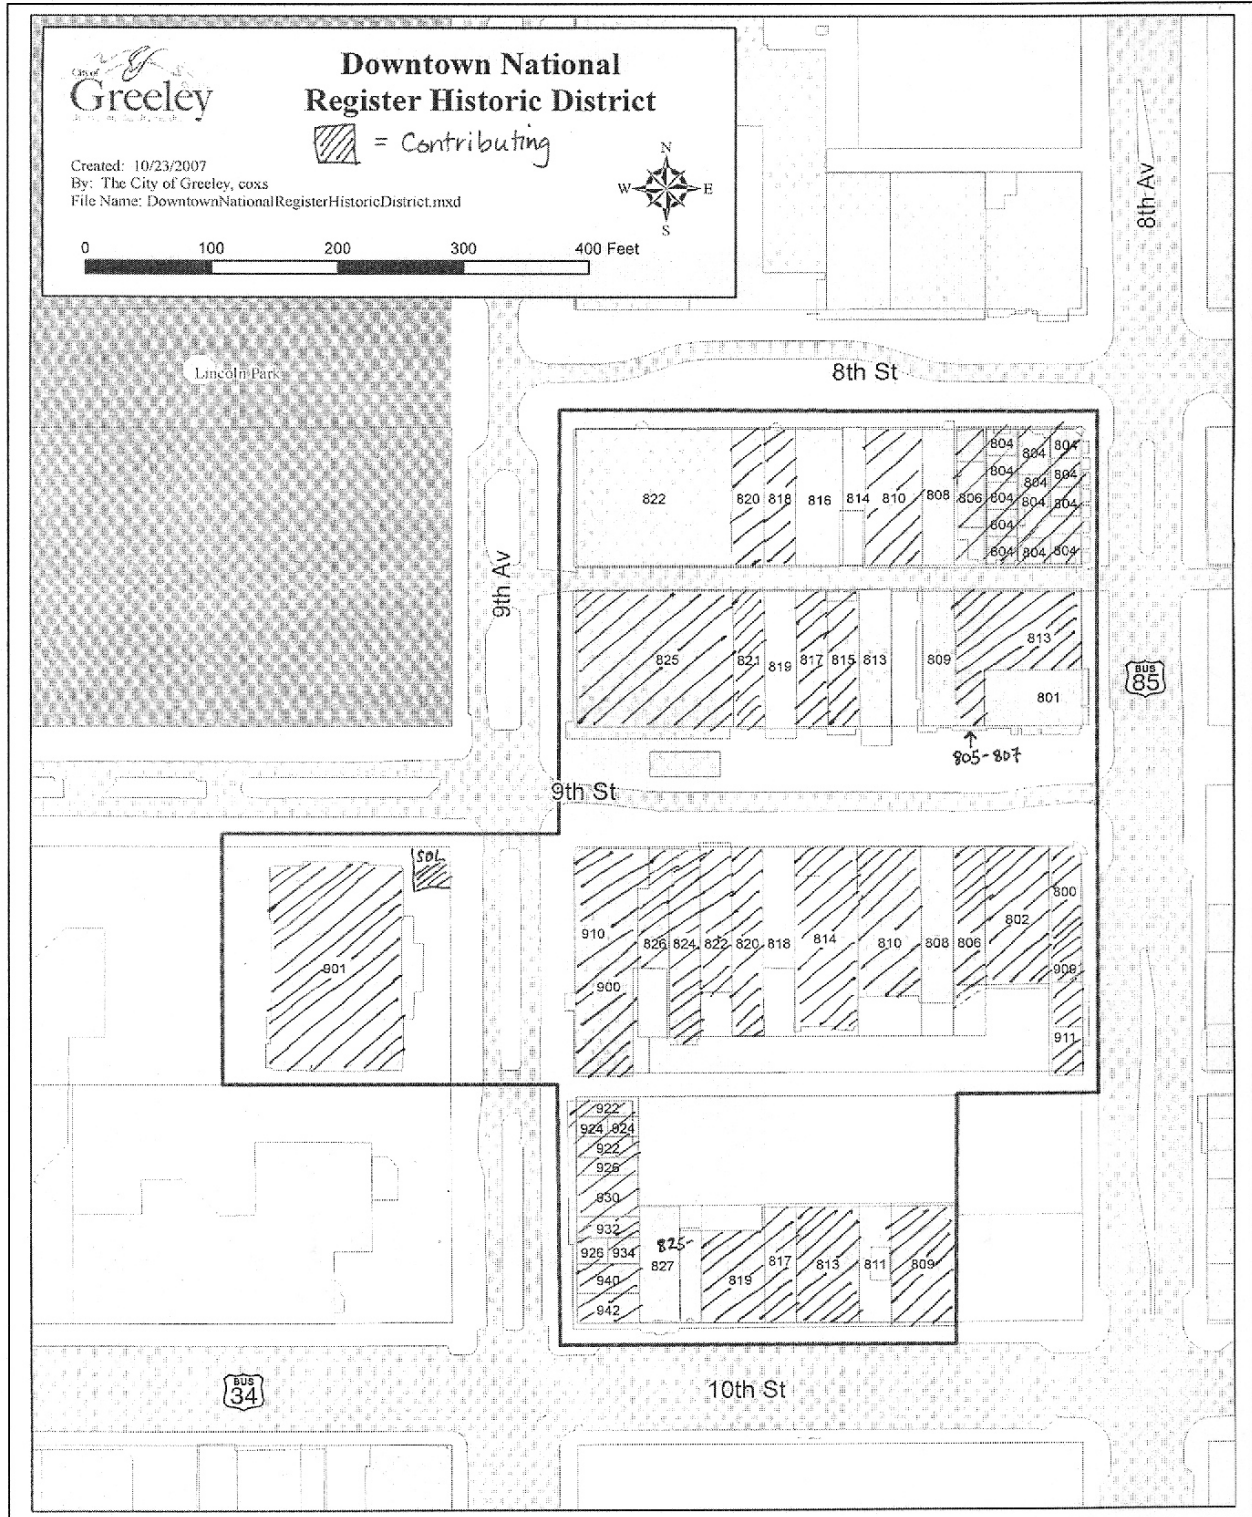
## Greeley Downtown Historic District Map

The district includes 44 buildings, including 32 contributing and 12 non-contributing buildings. Non-contributing buildings are either recent construction and not old enough or have been altered too substantially so as to not contribute to the district. Several buildings have recently been rehabilitated, increasing their integrity, and most are in good condition. The district is comprised of commercial buildings, including restaurants, offices, stores and lofts, and the county courthouse. The 1917 Weld County Courthouse was previously listed in the National Register of Historic Places in 1978.

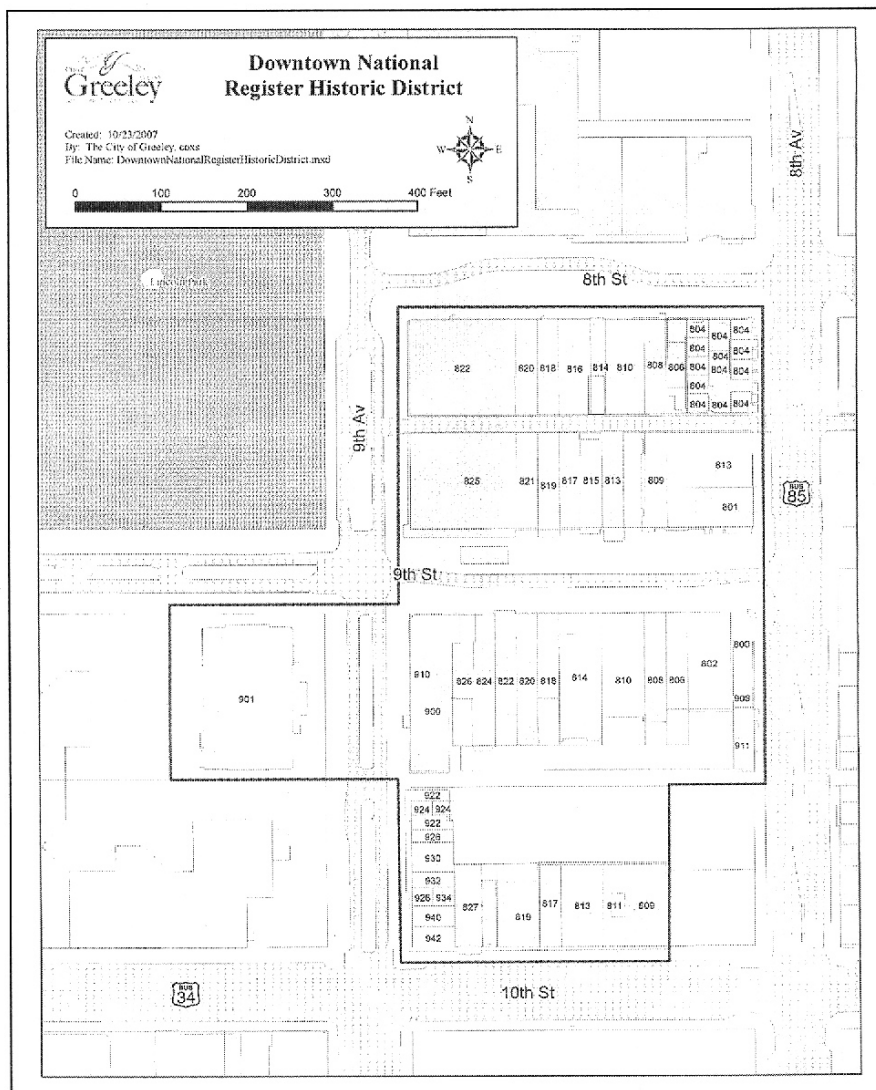
**Greeley Downtown District Boundary Map**

The district boundary was drawn to include the concentration of buildings with the highest level of architectural integrity and significance in the downtown and that were included in the original boundaries of the Union Colony.
