United States Department of the Interior
National Park Service
National Register of Historic Places
Registration Form

historic name Alexander House

Alexander House
Chaffee County, Colorado

DESCRIPTION

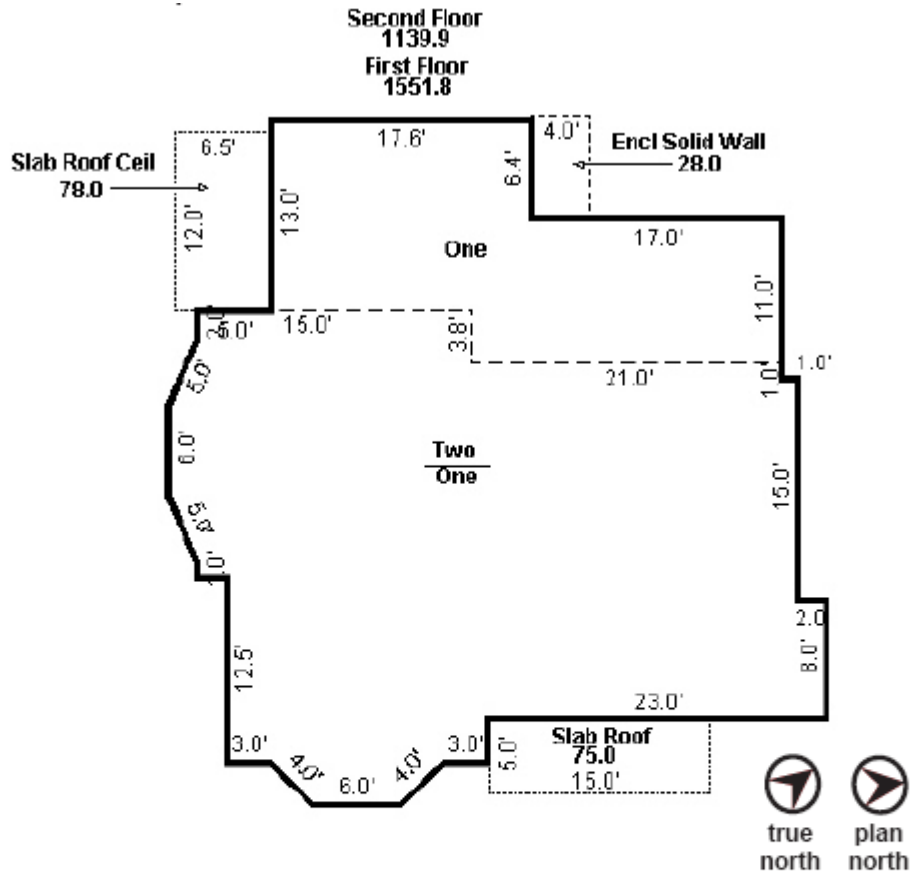
SKETCH PLAN 1: Footprint

Source/Note: This dimensioned footprint (Sketch Plan 1) of the Alexander House was acquired from the Chaffee County Assessor's Office located at the Salida courthouse. To create this footprint, measurements were taken along the exterior perimeter of the building. The two floor plan sketches (Sketch Plan 2 and 3) that follow were created with AutoCad and Illustrator by Lisa Schott. Interior photographs of the property and the dimensioned footprint were used as references. These highly simplified floor plans were created only to show the general layout of rooms and should not be considered a credible source for any other information.

The 1901 Alexander House is a two-story, Late Victorian Queen Anne style residence, with a rectangular (44' x 34') plan, a complex roof, and front and side porches. The walls are made of brick, the foundation of dark stone, and the roof of asphalt/composition shingles. The facade is asymmetrical. The interior of the house reflects the Victorian style. The house is located on a corner lot with the facade facing east onto F Street and a secondary elevation facing south onto 9th Street. The lot has a grass lawn and a concrete sidewalk in front, with a planting strip and large deciduous street trees. A chain-link fence on the south separates the side yard from a parking strip at the street's edge.

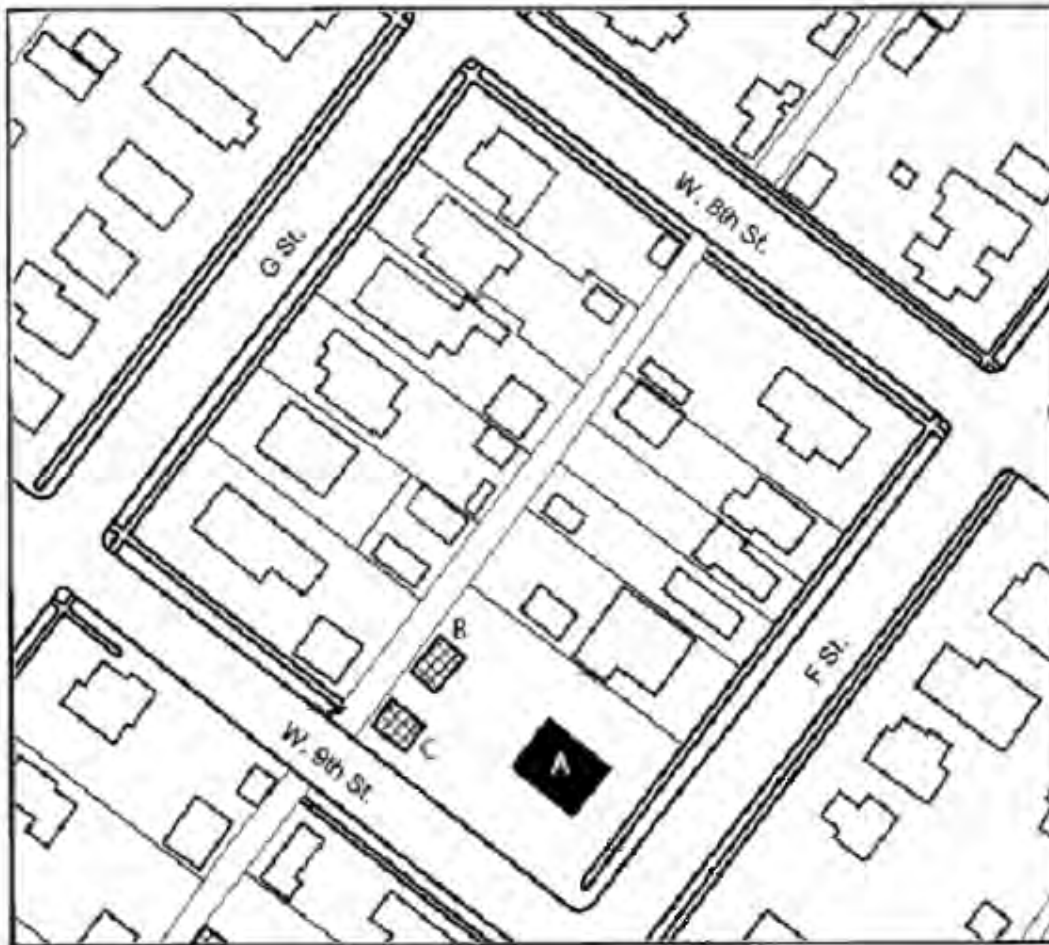
SKETCH MAP

- A – Alexander House
- B – Carriage House
- C – Garage

Two secondary buildings stand behind the house. The first is a one-story garage located at the southwest corner of the lot. The second, located just north of the first, is a one-and-one-half-story building whose design and materials echo the main building. The property is in excellent condition, and has experienced few alterations since its construction.
