National Register of Historic Places Registration Form

historic name Capilla de San Isidro
other names/site number Chapel of St. Isadore, 5CT.195

Culebra River Villages of Costilla County, Colorado
MPS

Costilla County, CO
County and State

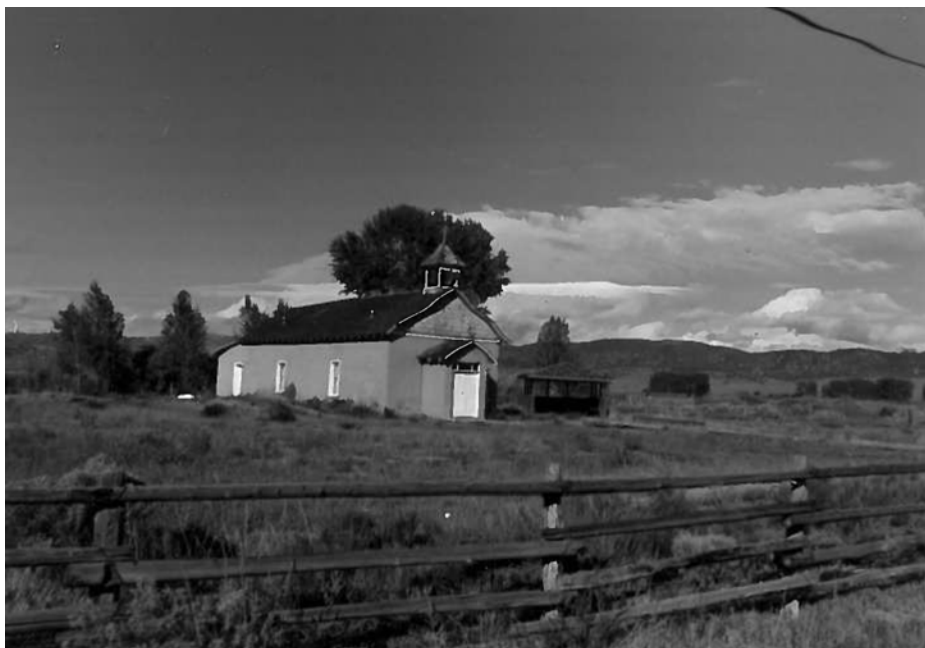
H002. Exterior View Church.
Source: Arnold Valdez, Costilla County Adobe Survey Historic Building Inventory Record, San Isidro Church (5CT.195), 22 Sep 1990, on file with the Office of Archaeology and Historic Preservation, History Colorado, Denver.

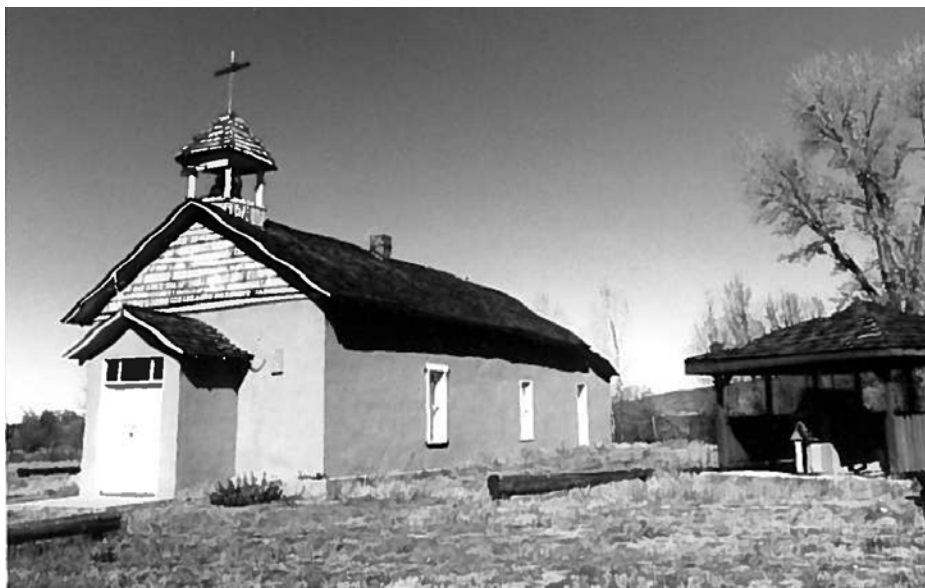
H003. Exterior View Church.
