United States Department of the Interior
National Park Service
National Register of Historic Places
Registration Form

historic name Moraine Park Museum and Amphitheater (additional documentation)

other names/site number Moraine Lodge/ Moraine Lodge Museum/ Moraine Park Visitor Center/ 5LR.477

Moraine Park Museum and Amphitheater
Larimer County/ Colorado

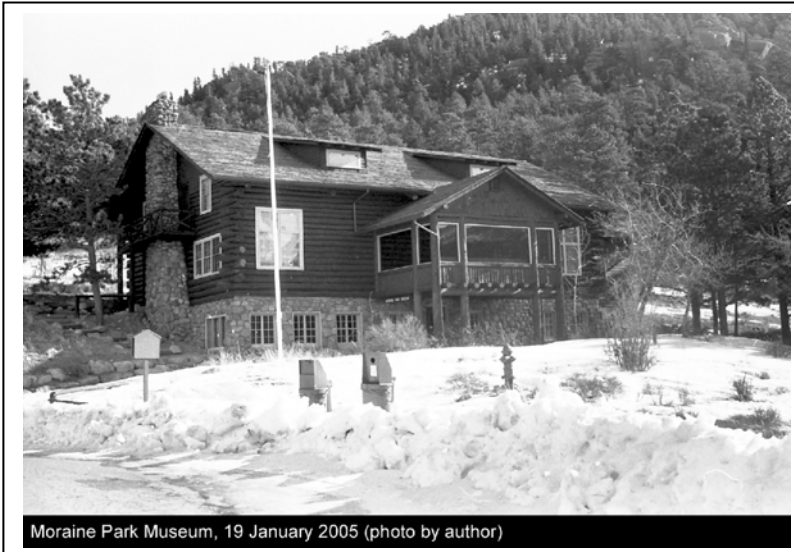
Moraine Park Museum, 19 January 2005 (photo by author)

The two-and-a-half story building faces southwest and has a side-gable roof with two shed dormers. The entire roof is covered in green-painted wood shingles that double every fifth course. The upper stories are of log construction, with log sizes ranging from 7 to 11 inches in diameter. The corners are not notched. The upper stories are painted dark brown.

The front or southwest elevation is two-and-a-half stories in two parts: the original building and, to the southeast, a 1991 addition. True divided-light, wood sash windows punctuate this elevation

in a symmetrical fashion. The windows on the upper stories are double-hung, while the first story contains casements. A two-story, front-gabled porch extends from the front of the building. The second story of the porch has large picture windows; the lower story is open for access to the front door. The upper part of the front door has one light; it is constructed of multiple layers of wood boards with tongue-and-groove joints, painted dark brown. The basement story, partially excavated into the hillside, is concrete veneered in uncoursed fieldstone. On the 1991 addition, there are 1-over-1 wood sash windows on both the first and second stories. A dark-brown painted steel door provides access to the first story of the addition. The first story of the addition is poured concrete, painted dark brown.

Centered on the west elevation and extending through the roof is a prominent, uncoursed stone chimney. A log balustrade porch surrounds the fieldstone chimney on the second story and is accessed through two tongue-and-groove doors.

The northeast elevation is one story due to the slope of the ground and has four 12/12 true divided-light hopper windows. There is one 6/6 hopper window to the west end. At the foundation, a concrete gutter/swale moves water to a steel drain grate.

The southeast elevation is dominated by a 1991 addition to the building. It has a hipped roof covered in green-painted wood shingles. Brown-painted, clapboard siding covers the addition, which sits on a dark-brown-painted poured-concrete foundation. The paired exterior doors are steel, painted dark brown.

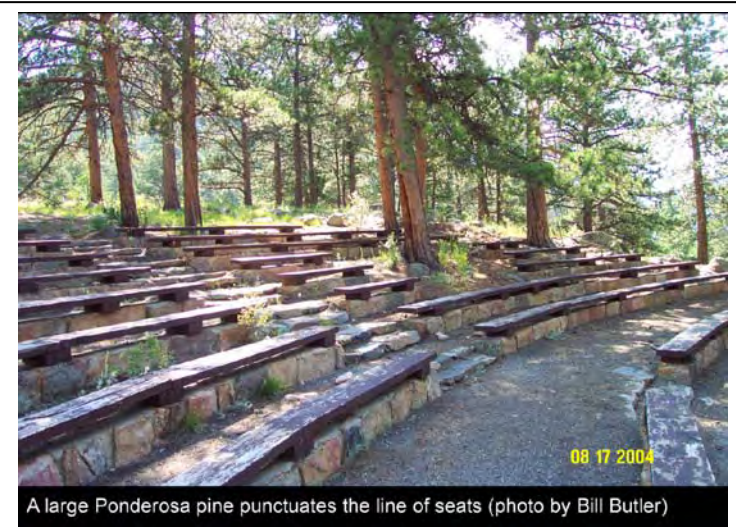
A large Ponderosa pine punctuates the line of seats (photo by Bill Butler)

Located about 100 feet northwest of the Museum lies the Moraine Park Amphitheater, an elliptical structure 125 feet long by 75 feet wide. The design maximizes the use of the bowl-shaped setting and native materials to carefully craft a space that blends with the environment, enhancing the naturalness of the site. The earth cut from the seating area of the amphitheater was likely used to create the terrace holding the stage.

Sixteen rows of seats in two arcs ascend from the stage area, arranged in an irregular fan shape, facing the stage and fire pit. The seats sit on somewhat regular stones some 10" high. Concrete mortar stabilizes the rocks holding the rectangular seating planks. Timber wedges (11" x 4") lie on these stone walls about 4-5 feet apart, with rectangular planks of milled lumber (2¼" x 11" x 4-6") nailed to the wedges. The joinery between the planks as well as the wedges use large unfinished nails. The planks are painted dark brown. The seating between rows 10 and 13 in the right arc is broken to accommodate an existing tree in a rectangular planting bed. Lighting fixtures installed under the seats remain but no longer function.

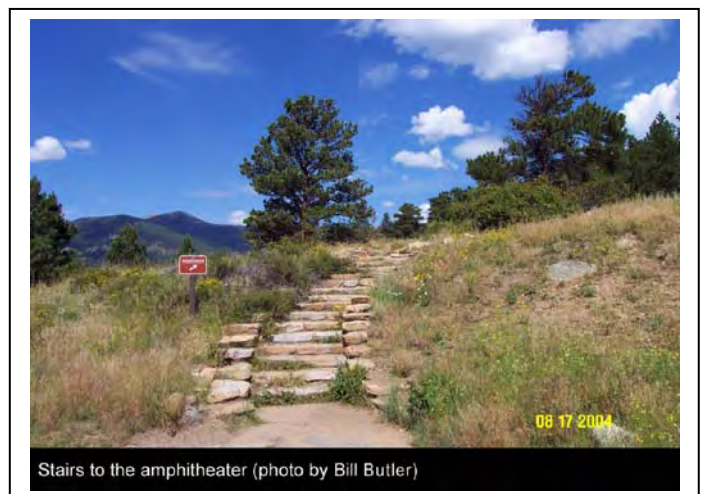
Stairs to the amphitheater (photo by Bill Butler)

Three main circulation paths with stone steps provide access to the seats. The aisle in the center is the most regular, about 4 feet wide. Those on the sides hug closely to the natural slope. Large stones and pines surround the northern corner of the seating area. The circulation path of the south side is defined by a line of pines.

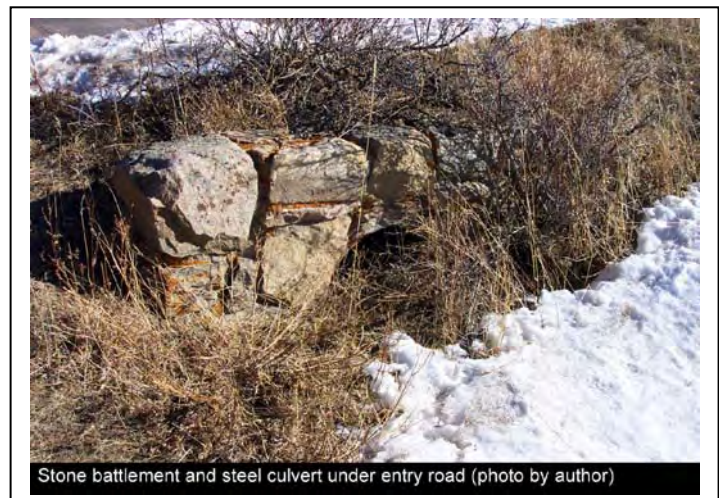
Stone battlement and steel culvert under entry road (photo by author)

Numerous stone drainage structures move water through the site. Drainage features include a 60-foot-long stone gutter above the amphitheater, which channels water into a drain. A steel drain grate lies behind the screen foundation at the edge of the stage area. At the bottom of the slope below the stage area, a 24-inch steel culvert with stone and concrete battlements channels water under the entry road.

Down the slope from this culvert, lies another stone battlement and culvert that carries water under Bear Lake Road. To the southeast, a second system of matching stone battlements and steel culverts moves water under the roads. This drainage pattern points to the elaborate construction techniques used in the creation of the site.

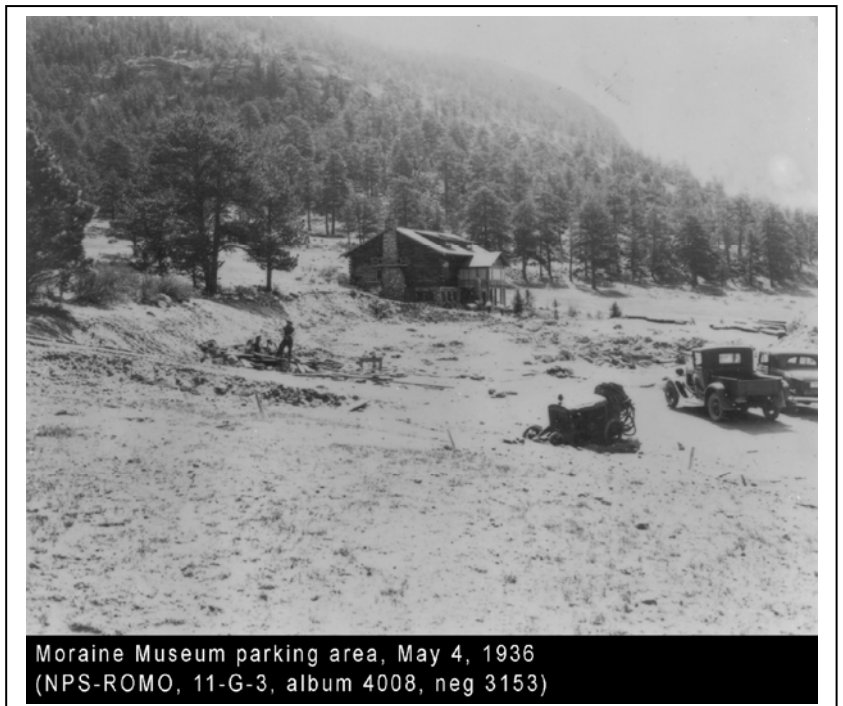
Moraine Museum parking area, May 4, 1936
(NPS-ROMO, 11-G-3, album 4008, neg 3153)

The 20-foot-wide, asphalt entry road has a 15% grade and feeds into an asphalt parking lot that serves approximately 65 cars. The sign by the entry reads "Moraine Park Museum" and is constructed of log posts and 11" x 2-1/2" boards painted tan. The parking lot is paved in asphalt and lined with 8-12 inch diameter log curbs. A central island holds native shrubs, grasses, and one small ponderosa pine. Two, four-foot-tall steel bases that hold telescopes for interpretive programs sit on the east end of the island. On the south side of the parking lot, a 4-foot asphalt sidewalk lines the edge of the lot. Along this path, three modern, black steel wayside signs face Moraine Park and tell the story of some of the non-extant lodges, of the glacial history of Moraine Park, and of artists in the park (i.e. Albert Bierdstadt). Along this asphalt path near the museum lie two bear-proof garbage cans (one brown-painted and one green-painted); another brown-painted garbage can sits just outside the front door. Along the asphalt sidewalk to the museum's front door is a 15-inch-tall log "bumper" fence, made of 6-inch logs to prevent visitors from wandering off trail. The north side of this same asphalt sidewalk is lined with large granite boulders that both retain the slope above and serve as seating for visitors. This wall blends into a set of stone stairs that wrap around the fireplace and connect to the interpretive trail. A red fire hydrant stands in the grass near the front door. When the museum is open, the flag on the pole in front of the lodge constantly snaps in the wind. Two rustic, half-log benches allow visitors to admire the view of Longs Peak from the front door. Two small, wood signs teach visitors about native vegetation.

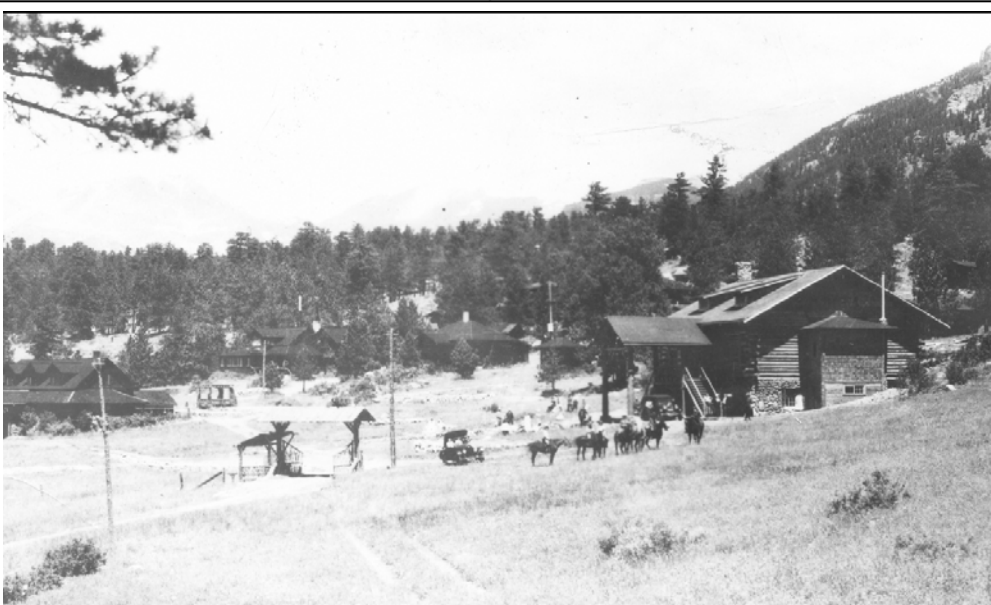
Moraine Park Lodge's Assembly Hall (now Moraine Park Museum), ca. 1925
(NPS-ROMO, 10-C-1-I neg 272)

ceremonies ushered the fine new rustic assembly hall just completed at Moraine Lodge into the center of the social activities of the popular resort." In 1928, following MacPherson's death at age 84, her family continued to run the resort. Between 1929 and 1931, they leased the Moraine Lodge to J. Russell McKelvey, who later ran the Fall River Lodge in Horseshoe Park. In the fall of 1931, amid the Great Depression, the National Park

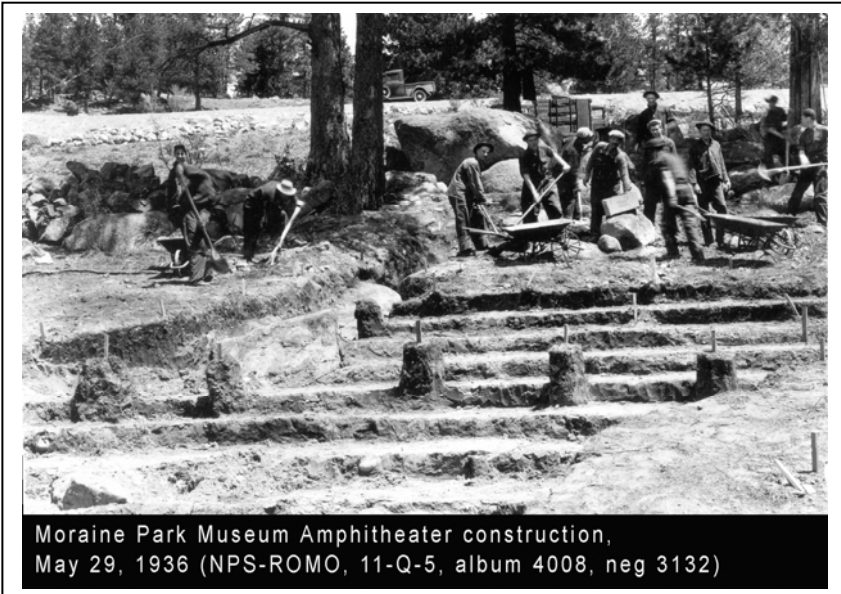
Moraine Park Museum Amphitheater construction,
May 29, 1936 (NPS-ROMO, 11-Q-5, album 4008, neg 3132)

However, construction on the site was still underway a year later, as is evident from the Superintendent's Monthly Report from May 1937: "In the Moraine Museum area the following E.C.W. construction is under way: the steps to the amphitheater, the trail to the amphitheater, the path to the museum, sodding slopes, surfacing the parking area, erosion control, and cementing of steps in amphitheater." The Superintendent's Monthly Report from June 1937 states that "The Moraine Park Amphitheater and parking area are fast rounding into shape and should be completed early next month. This job has been one of the largest that E.C.W. crews have been placed on, and has taken them a year to complete. The job called for many types of works, including log, rock, cement, grading and landscaping. When completed, it will be an excellent improvement to the park." The amphitheater was opened to the public on August 6, 1937, and "its first meeting drew 97 people, a very encouraging prospect for the new centralized lecture program."⁴
