United States Department of the Interior
National Park Service
National Register of Historic Places
Registration Form

historic name Willow Creek Park

Willow Creek Park
Name of Property

New Deal Resources on Colorado's Eastern Plains

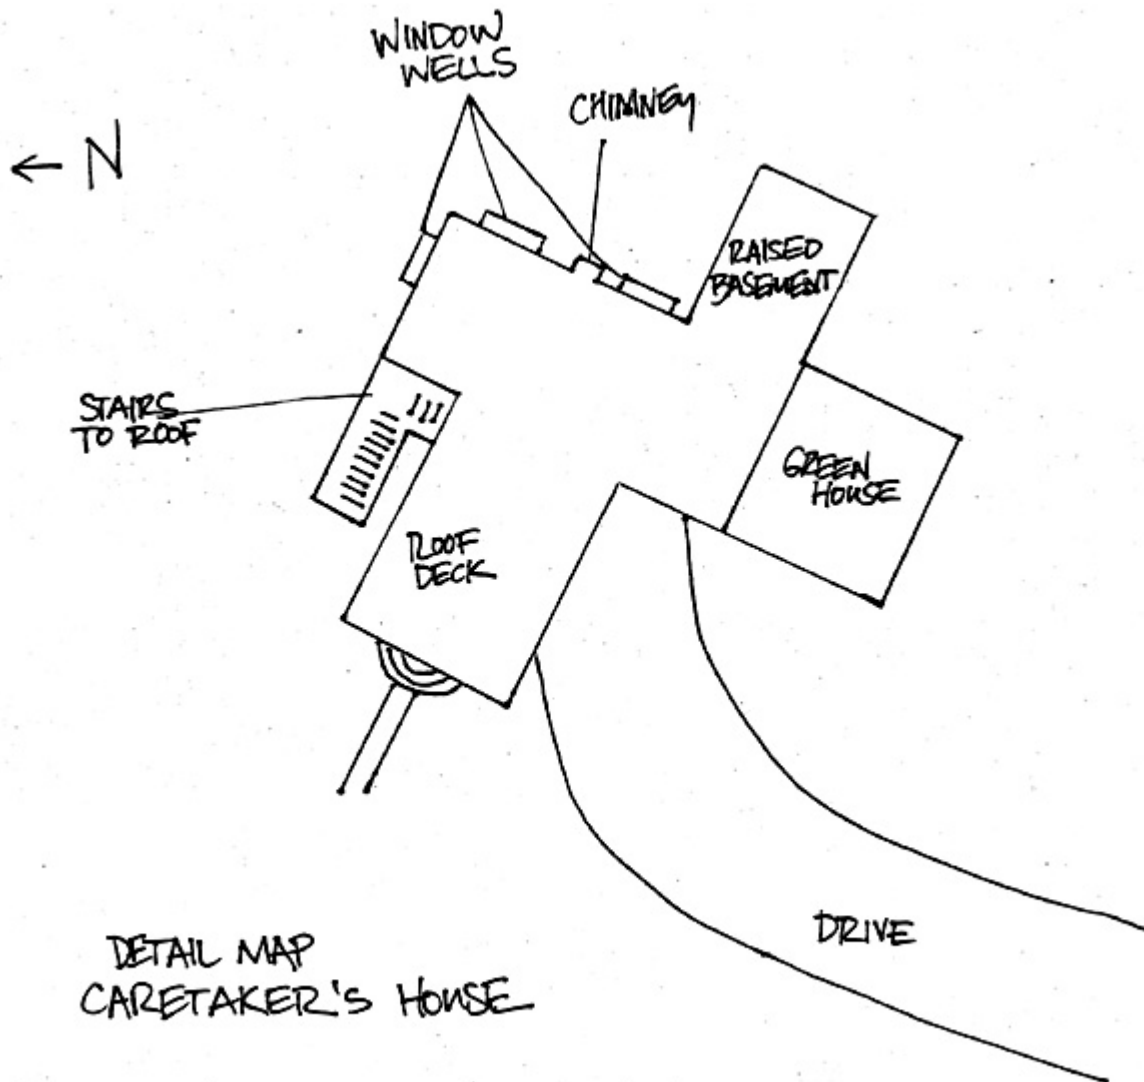
DETAIL MAP
CARETAKER'S HOUSE

The house consists of a rear (southeast) rectangular section (measuring 16' x 39') and a front (northwest) rectangular section (measuring 19' x 27') that is set at a right angle to the rear section. A greenhouse is attached to the southwest side of rear section. The building foundation is stone. Windows are single or paired 6-over-6 wood-sash set within deeply recessed openings featuring slab-rock slanting sills. The rear section is slightly taller than the front section. A roof deck is located on the front section. Stone stairs are located at the north corner of the building (photo 11). The stairs are freestanding until they reach the northwest side of the rear section where they turn and continue up the northwest wall of the rear section to reach the roof of the front section. The roof of the front section has a parapet wall on the northwest and stone pillars connected by a metal rail balustrade on the northeast and southwest sides. The rear section has parapet walls on the northwest, northeast, and southwest sides (see detail map).

The entrance is centered on the northwest wall of the front section (photo 10). A flagstone path with several steps leads to the front entrance. Three semi-circular steps constructed of ashlar blocks lead up to the front door. The single door is wood covered by a newer screen door. Single windows are located on either side of the door. There is a paired window on the northeast side of the front section; a single and a paired window are located on the southwest side. Wood vigas extend across the front section, protruding on the northeast and southwest sides.

Another entrance is located on the northwest side of the rear section, through a wooden sliding garage door (photo 13). A paired window is located above the door. On the northeast side there are paired windows at the main level and basement level. The basement level window extends below grade with a window well. On the southeast (rear) side there are a single window, a paired window, and a smaller 1-over-1 wood-frame sash window on the main level (photo 12). There are two paired windows with window wells at the basement level. An exterior chimney is located near the center of the southeast side. A raised basement section (measuring 12' x 18') extending east from the south corner of the

building is comprised of a 4' stone wall with concrete roof; this covers a basement room. The greenhouse (measuring 16' x 18') sits slightly below grade and has a gabled asphalt roof. A curving gravel drive with a low stone retaining wall leads from the park drive to the southwest side of building.
